DYNASYS TECHNICAL SERVICE BULLETIN

TSB – 01.20.21

Re: Dynasys Generation 3 Series APU units

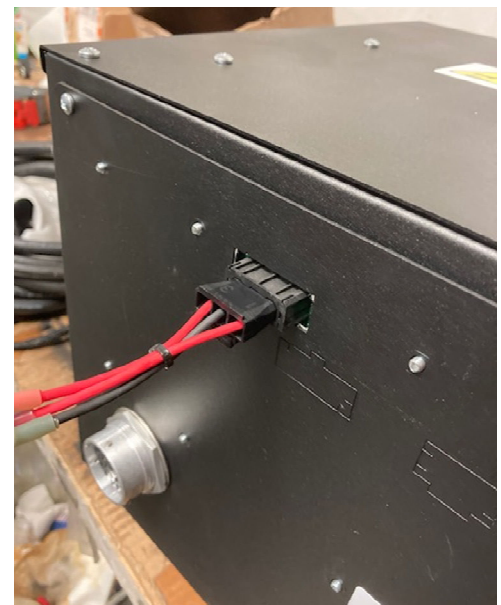
System software change is required in all GEN3, EIS, and 8KW product lines. There is a potential time rollover event that can cause overheat damage to the engine cooling system. All customers should be notified to come into a dealer to have their software updated.

Customers who cannot immediately come into the dealerships for re-programming **MUST** be informed to cycle the power to the control system every 30 days, this will re-set computer timers.

This is accomplished by unplugging the 3-prong connector on the side of the control (red-black-red) then counting 30 seconds before plugging it back in. This re-sets the timer.
