DYNASYS TECHNICAL SERVICE BULLETIN

TSB – 06/05/15

Re: Dynasys Generation 2 Series APU units

Affected Units:
The following documentation pertains to those APU serial numbers G2D20001 to **G2D20775**

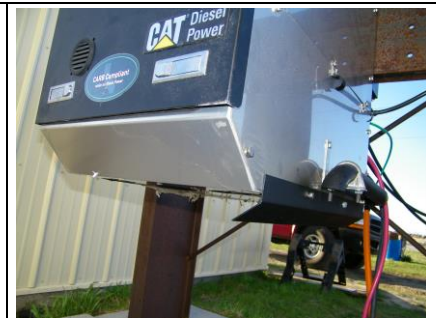
Notice:
. Premature Lower Fan failure cause has been identified as airflow through the APU when the truck is at highway speeds. The pinwheel effect spins the fan motors to over speed, and or in reverse.

Installation of the Air Diverter.:

- 1: Locate and remove the two center 11mm head bottom cover mounting bolts on the lower leading edge of the APU.
 - 2: Attach the Air Diverter with the two 11mm head bottom cover mounting bolts and tighten to 50 inch lbs.
- Return to Service
